Radiographic Findings:

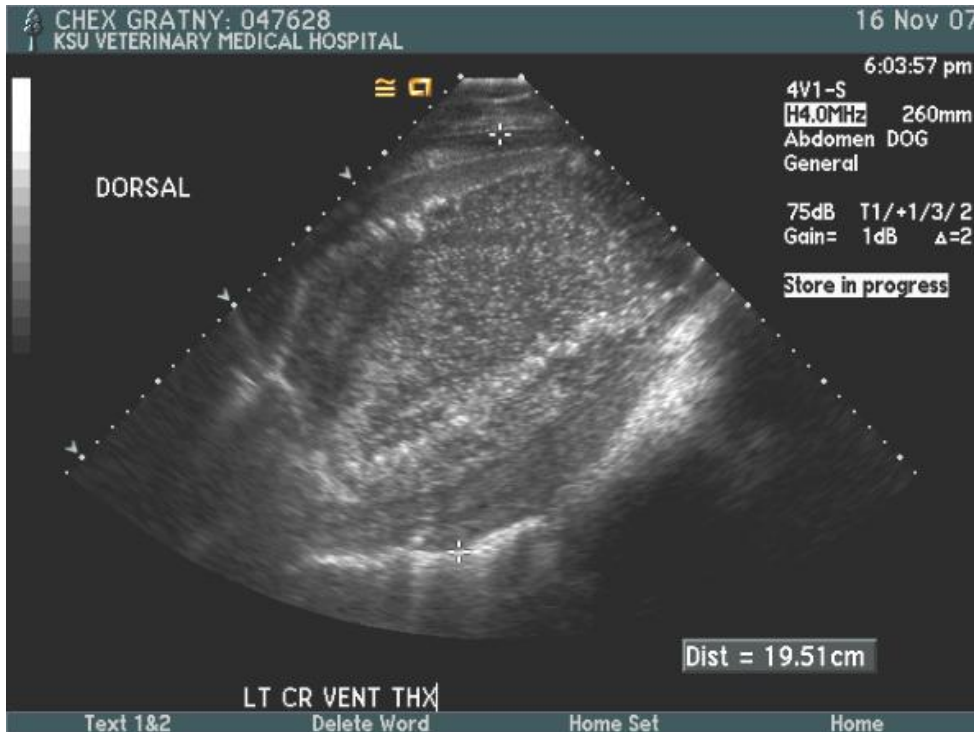
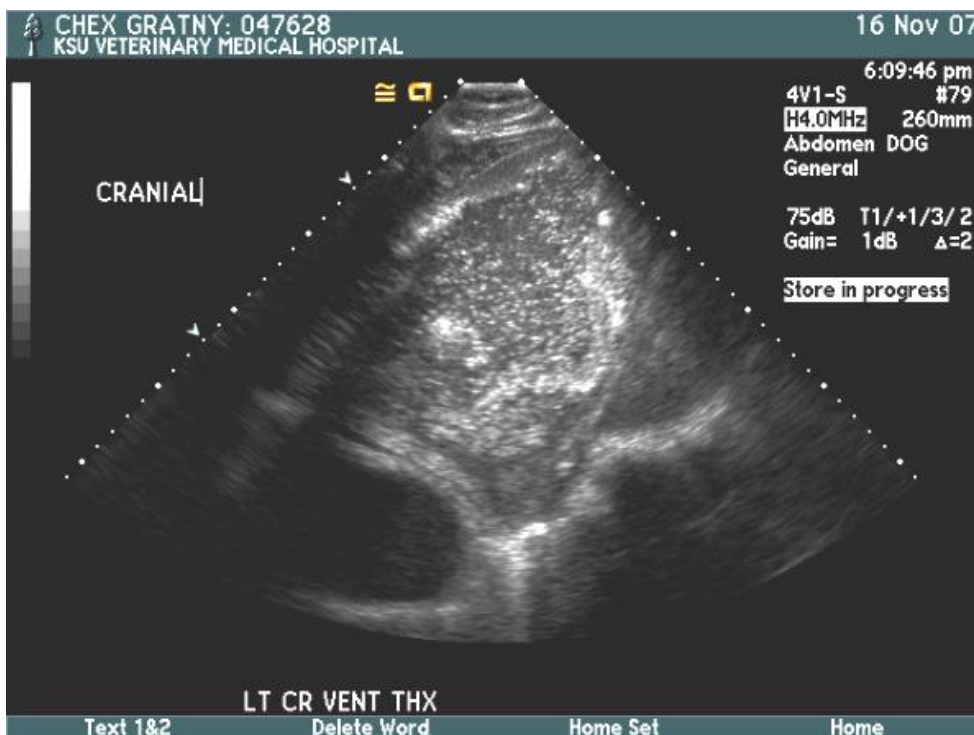
There is a 2cm in width curvilinear band of soft tissue extending from the cranial heart base caudally to the diaphragm. A fluid and gas interface is seen 7.5cm ventral to this structure. The soft tissue opacity within the ventral thorax is causing border effacement with the heart and diaphragm.

Abscessation (pleural or pulmonary) with pleuropneumonia.
